# ACO DRAIN

## Clifton Hill Niagara Falls, ON

### ACO PORTFOLIO

#### *FG200 with ADA ductile iron grates*

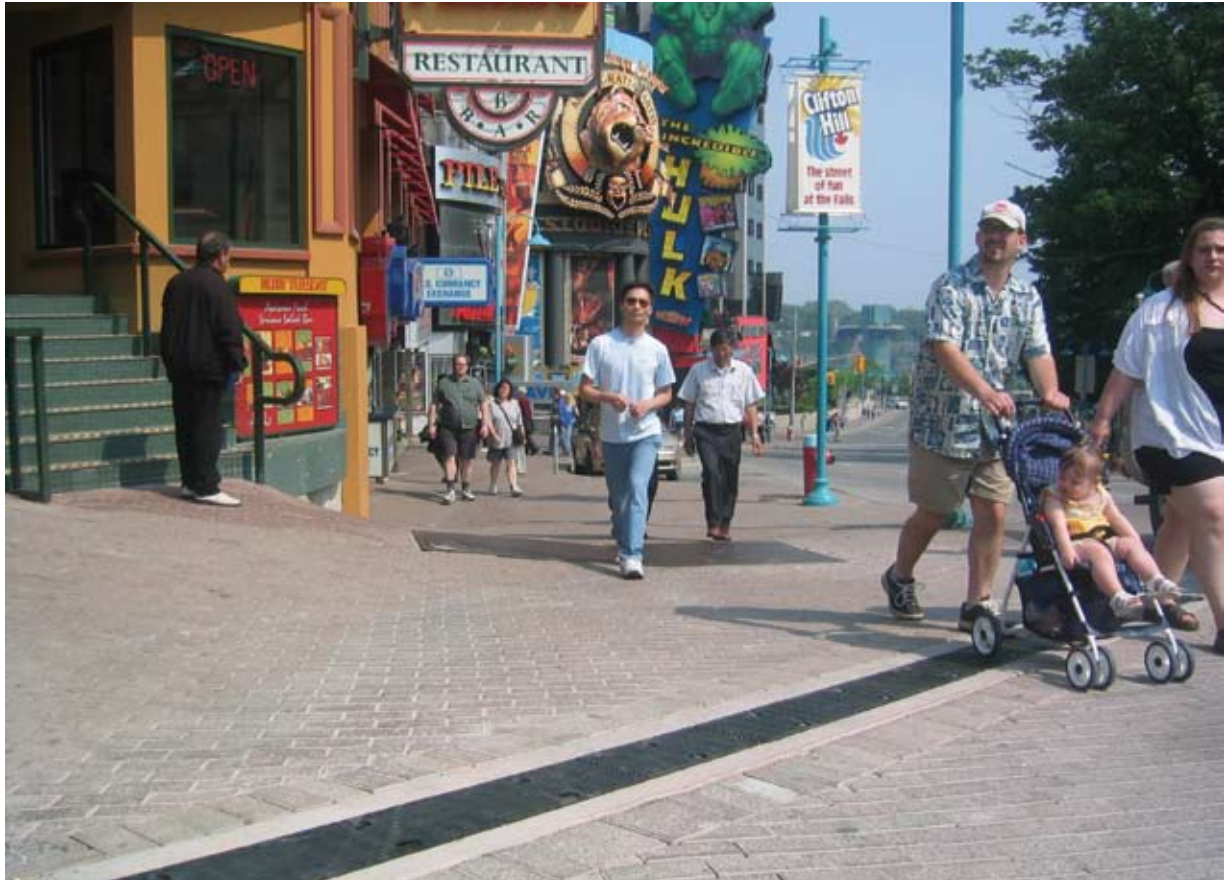
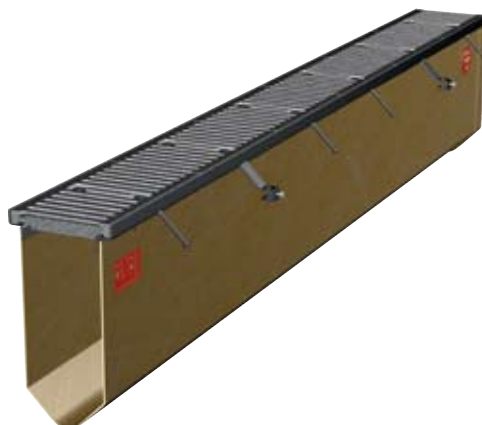
Due to the steep incline, engineers were having difficulty finding a drainage system that could intercept the heavy rain fall. To solve the problem, ACO's FG200 fiberglass trench drain system was installed for its large hydraulic capacity and long run capabilities.

By using ADA compliant ductile iron grates, tourists were able to cross the trench drain safely, while the Load Class E rating provided the strong grates needed to withstand vehicular traffic.
