ACO DRAIN

Bank of Montreal Headquarters Calgary, AB

ACO PORTFOLIO

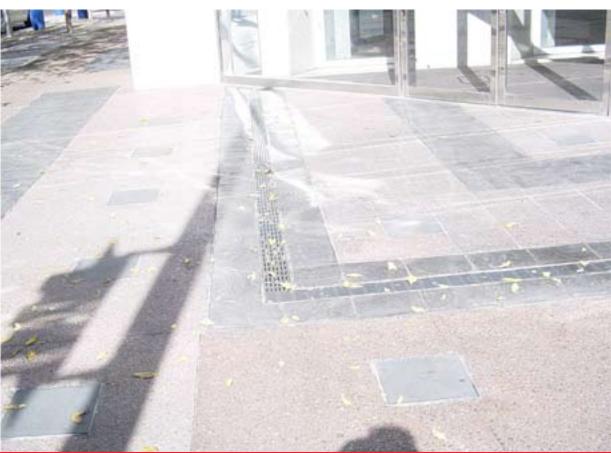
The biggest problem facing the Bank of Montreal in downtown Calgary were sidewalks that sloped towards the building. The nearby catch basins were not catching nearly enough of the water and flooding in the entrance was a problem. ACO's H80 SlabDrain was chosen to create a barrier around the entrance to intercept water and prevent it from reaching the interior. The H80 SlabDrain with Type 478 ADA grate was used because the parking garage structure was located only 4" below the surface. A shallow trench was needed since the parking garage had to remain untouched for safety and structural reasons.

The ADA grate also meant that pedestrian traffic of all kinds could cross the trench drain without any problems.
