**CNE Horsebarn Animal Center,
Toronto, ON**

ACO PORTFOLIO

KS100S with Type 440 fiberglass grates

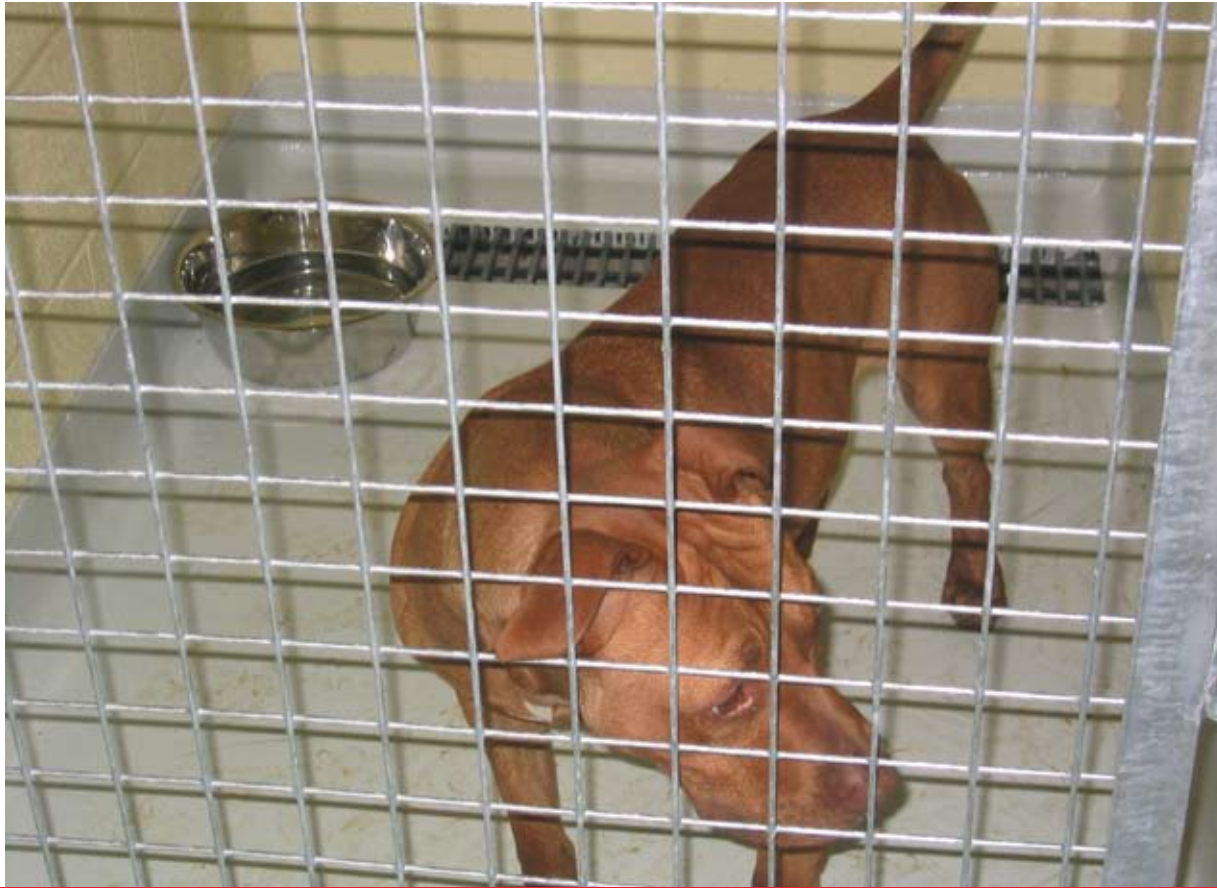
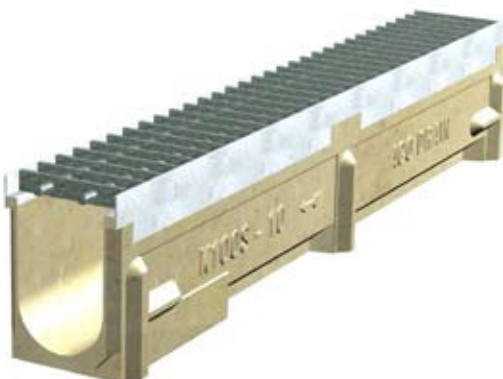
The kennel area where the dogs are housed has a sloped floor to enable quick and easy wash down of spilled food and animal waste. A trench drain was needed to drain away the washwater and waste.

KS100S with fiberglass grates was chosen as the stainless steel rail and fiberglass grate are both corrosion resistant to the waste matter and cleaning fluids used.

The large openings on the 440 grate are not easily blocked and have the hydraulic capacity to drain high volumes of water from a pressure hose, to make kennel cleaning as quick and effective as possible.
